FAILURE ANALYSIS ON SLINGER DISK PIPE OF PURIFIED TEREPHTHALIC ACID (PTA) VESSEL

Sukandar^a, Triwibowo^a, Yana Heryana^a

^a Balai Besar Teknologi Kekuatan Struktur (B2TKS), Badan Pengkajian dan Penerapan
Teknologi (BPPT), PUSPIPTEK, Serpong, 15314, Indonesia
e-mail: sukandar@bppt.go.id, triwibowo@yahoo.com, yana.heryana@bppt.go.id

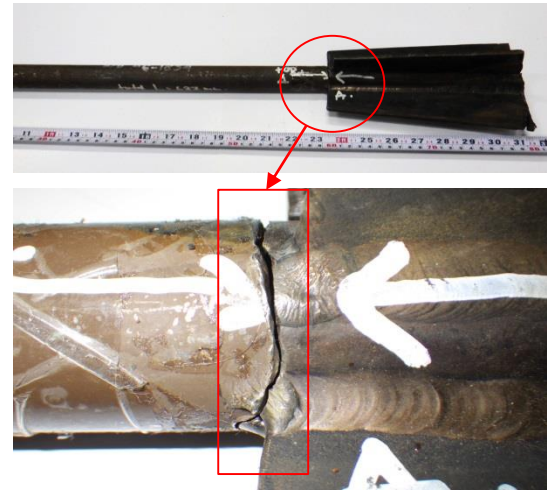
Failure took place on the both pipes of the slinger disk pipe at the strengthening

plates tip. For this failure analysis, it is taken one failure pipe as sample (Figure 2 and 3).

Figure 3. Location of Fracture on The Slinger Disk Pipe (Red Circle And Magnified In Red Square)

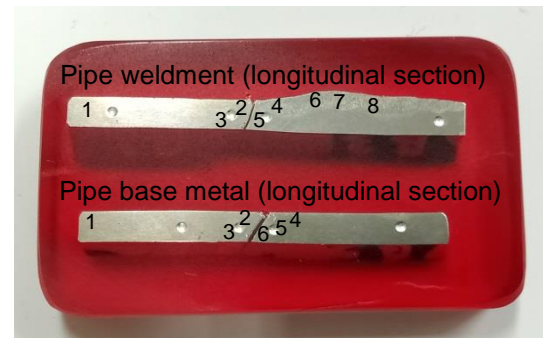
Figure 4.

Location of Hardness Tests on The Sample of Slinger Disk Pipe

Hardness test result as represented by a sample of slinger disk pipe shows that the material hardness is in accordance with the standard of lean duplex 2205 as shown in Table 4.

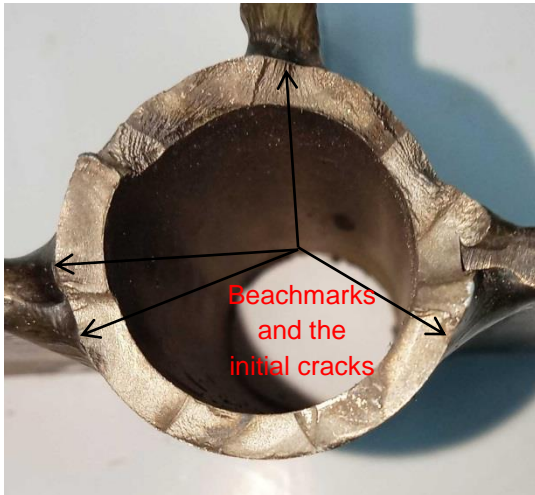
Figure 5.

Examination result of fractography on the fracture surface of slinger disk pipe shows multiple beachmarks and their initial cracks as an evidence of fatigue fracture under reverse bending load as shown in Figure 5-6.

Initial crack of each beachmarks are located at the center of beachmark.

Multiple Beachmarks on The Fracture Surface And Their Initial Cracks Location

As can be seen in the Figure 5 that the beachmarks position are diametrically opposite each other in the same transverse plane, it indicates that the applied bending moment is reversing (alternating), all point in pipe are subjected alternately to tension and compression stress²⁾. It means that the rotation of slinger disk pipe is reversing (alternating).

Moreover, it can be observed that the area of beachmarks are relatively reach more than half of cross section area of the

pipe (Figure 5). It indicated that the nominal load on the slinger disk pipe is low.

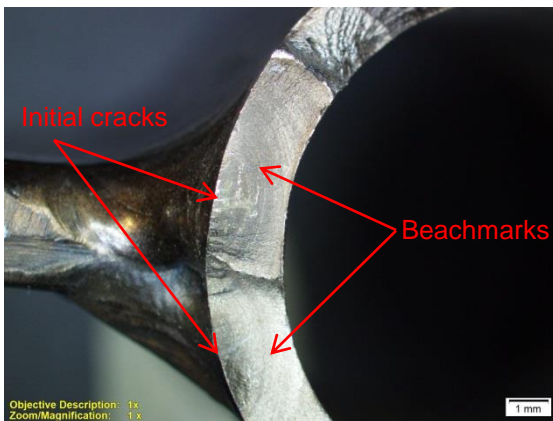
Figure 6.

Magnification of Figure 5 Shows Two Beachmarks With The Cracks Initiated From Two Weld Joints

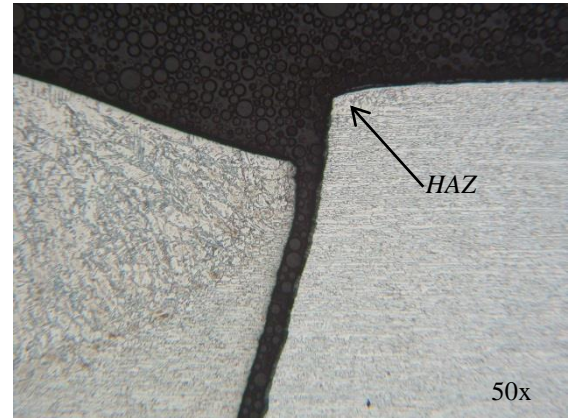
Examination result of metallography shows that the crack propagation initiated from HAZ which then propagated to base metal, while the microstructure is austenite in ferrite matrix³⁾ in normal condition⁴⁾, as shown in Figure 7.

The Fracture is Initiated From HAZ Which Then Propagated to Base Metal.

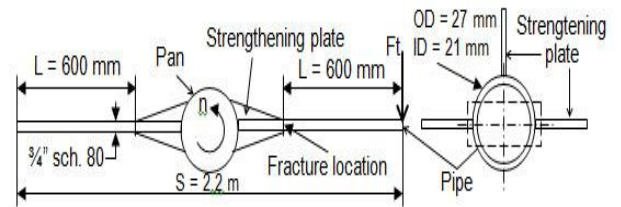
Figure 7. Dimension of Slinger Disk Pipe

Bending stress at the plate tip $\sigma_B = Mr/I = 2,605,675 \times 13.5 / 16,532 = 2,128 \text{ N/mm}^2$

Calculation result is maximum stress σ_B is higher than the tensile strength of material.

Pipe selection: 1½" schedule 40

- With the motor power is 30 kW and the rotation is 60 rpm, the maximum bending stress on the location of fracture is above tensile strength of lean duplex 2205
- With the motor power is 30 kW and the rotation is 60 rpm, need pipe dimension of 1½" sch. 40
- With the pipe dimension of ¾" schedule 80, the power should be limited up to 4.54 kW
