BRIN
BADAN RISET
DAN INOVASI NASIONAL

Measurement of Geometric Variations of a Railway Truss Bridge (Case Study: BH77 Railway Bridge)

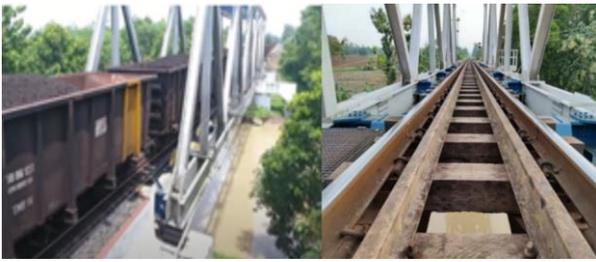
Figure 2. The BH 77 Tegineneng railway bridge perspective.

control. This research was conducted at the BH 77 Railway Bridge in Tegeneng, Tanjungkarang-Martapura, Lampung. The location of the railway bridge is presented in **Figure 1**. This location was chosen to fit the research criteria that was also conducted by *Badan Riset dan Inovasi Nasional* (National Research and Innovation Agency of Indonesia) [7]. The railway truss bridge is a Warren configuration. The steel frame bridge used is the WF profiles and the angled profiles, which are known based on the results of the direct inspection in the field. **Figure 2** shows the bridge and its surrounding environment.

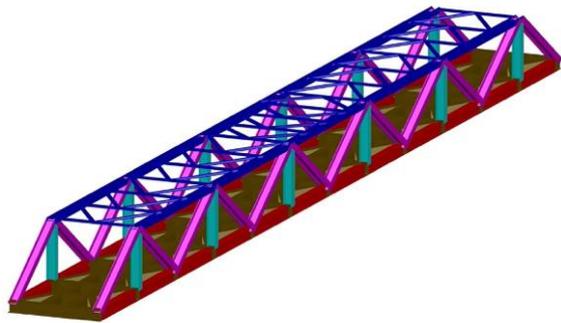
Figure 4. The railway bridge of the case study.

This research was conducted on the existing steel Railway Bridge BH77, in Tegineneng, Tanjungkarang-Martapura Crossing, Lampung. This railway bridge are warren type steel frame configuration. In reference to as built drawing, the railway bridge has a vertical height of 8 m, a lower span of 61.6 m, an upper span of 53 m, and a width of 4.8 m with detailed drawings as shown in **Figure 4**.

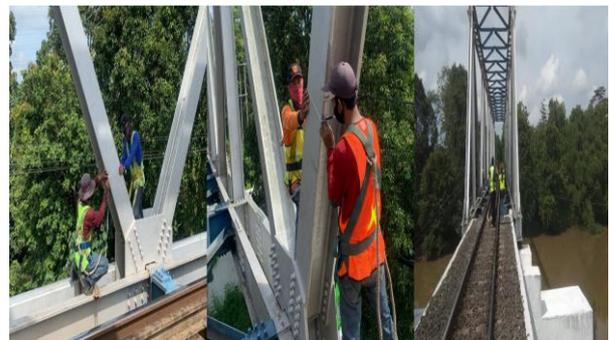
Figure 6. Dimension measurements activities.

Field measurements were performed in order to obtain the dimensions of the railway bridge members. **Figure 6** shows dimension measurement activities in the field. Measurements were done by grouping four

measurements, namely the bottom length, upper length, the height of the bridge and the width of the bridge, respectively. Measurements were carried out by comparing the original dimensions according to the as-built drawings and current measurements in the field. Comparison bridge detail dimension is presented in **Table 2**. It can be noticed that bridge dimensions have been changed. This elongation may be caused by loading and exposure to continuous sunlight. In order to avoid structural deterioration, continuous maintenance is required. Therefore, it is necessary to monitor the health of the bridge structure so that bridge maintenance mitigation can be carried out regularly.

Based on the results of measurements of the truss that have been carried out, there are many values of the circumference of the truss that has a value greater than the stated value based on as-built drawing with a standard deviation that varies in each variation of its dimensions.

The circumference of the truss that has a value greater than the stated value based on as-built drawing happens because the bridge frame has been painted several times to avoid corrosion of the steel structure. With varying measurement results obtained, it is necessary to do structural modeling to include wide variations cross-section so that the minimum strength of the bridge structure can be determined. The strength of the railway bridge might be affected by changes in the cross-sectional area.

Structural deterioration possibly would happen in the future. Therefore, monitoring and evaluation should be performed regularly to avoid structural collapse.

Structural modelling should be carried out to understand the minimum strength capacity of the railway bridge.
