FAILURE ANALYSIS ON SLINGER DISK PIPE OF PURIFIED TEREPHTHALIC ACID (PTA) VESSEL

Sukandar^a, Triwibowo^a, Yana Heryana^a

^a Balai Besar Teknologi Kekuatan Struktur (B2TKS), Badan Pengkajian dan Penerapan
Teknologi (BPPT), PUSPIPTEK, Serpong, 15314, Indonesia
e-mail: sukandar@bppt.go.id, triwibowo@yahoo.com, yana.heryana@bppt.go.id

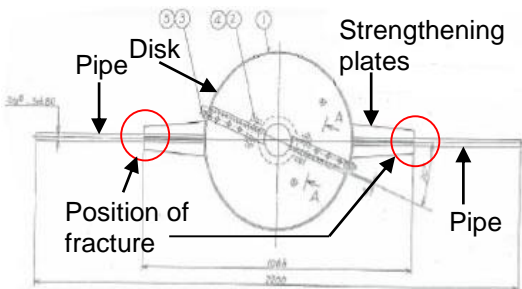
Figure 2. The Slinger Disk Pipe Structure

Failure took place on the both pipes of the slinger disk pipe at the strengthening

plates tip. For this failure analysis, it is taken one failure pipe as sample (Figure 2 and 3).
